Laboratory Measurement of Impact Sound Insulation of Floor Coverings on a Heavyweight Concrete Slab Floor

Report INR183/R1
April 2013

Golden Field Corporation Pty Ltd
13 Olver Street
Preston
VIC, 3072

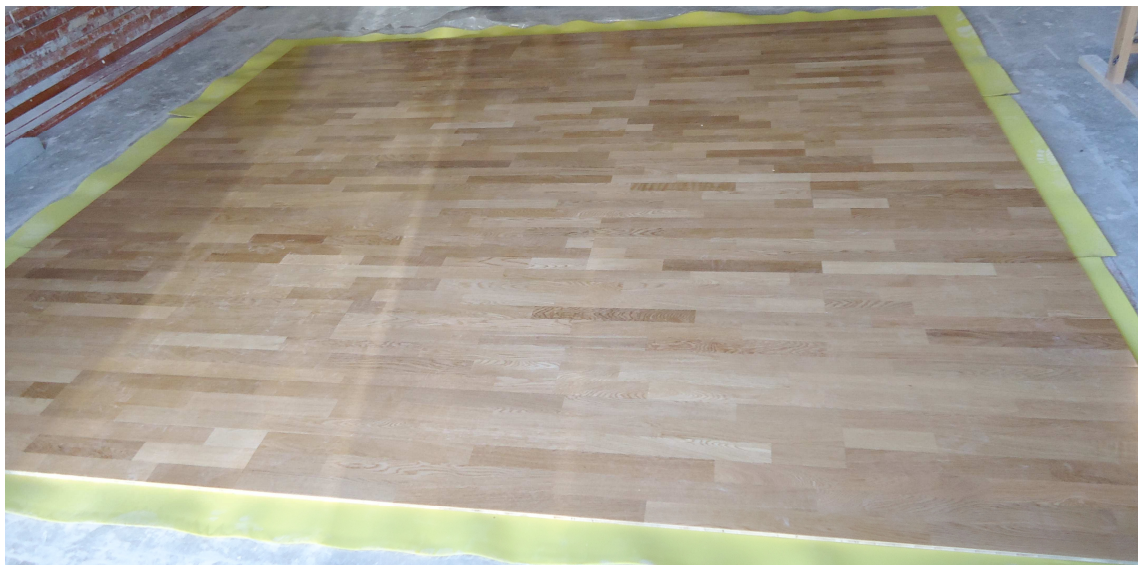
Figure 1, Engineered Hardwood flooring, as installed.

Floor system for test INR183-1	
Materials (from top down)	Details
• 14 mm Engineered Hardwood flooring	Golden Field Prefinished Engineered 3-Ply Parquet hardwood flooring (lacquered 3-strip rustic oak) with tongue and groove edge profiles. Plank size: 14 mm thick x 2200 x 189 mm. Area mass: approx 7.2 kg/m ² .

• GREENEARTH EVA Acoustic underlay	3 mm neoprene underlay with 60 micron vapour barrier. Supplied in 20 m ² rolls, 1100 mm wide, with pre-applied adhesive tape and 8 cm vapour barrier overlap. Area mass: approx 0.36 kg/m ² .

- The engineered hardwood flooring was laid over the underlay, covering the test area of the 150 mm thick concrete test floor of the laboratory.
- Following the first test, the engineered hardwood flooring was removed and replaced with the laminate flooring.

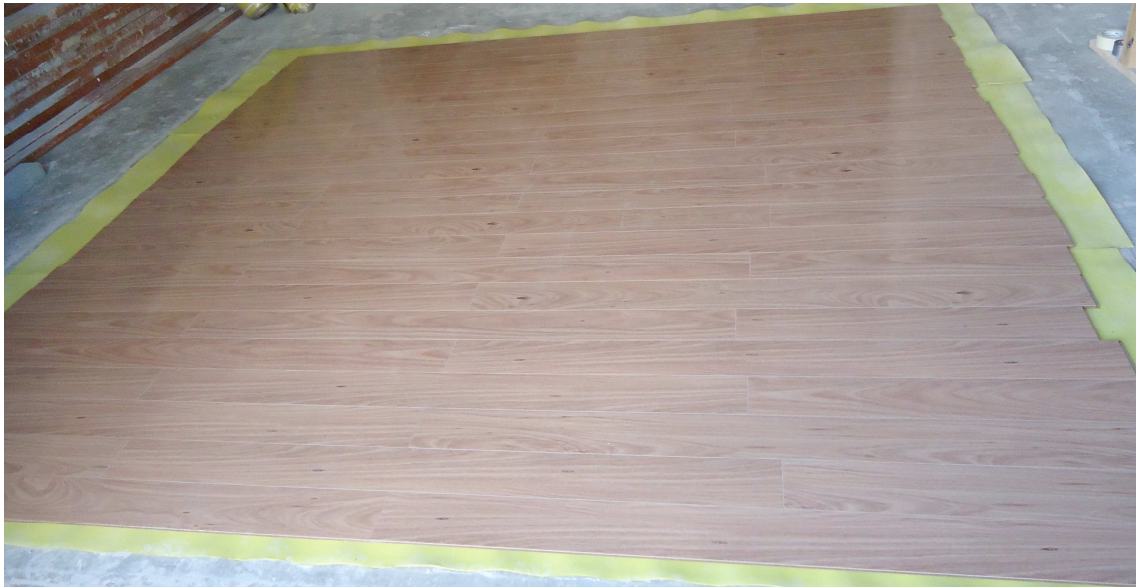
Figure 2, Laminate flooring, as installed.

• 12 mm Timber Laminate flooring	Golden Field GE2-005 "Rose Gum" 12 mm timber laminate flooring with interlocking edge profile. Plank size: 12.3 mm thick x 1800 x 143 mm. Area mass: approx 10.8 kg/m ² .

• GREENEARTH EVA Acoustic underlay	3 mm neoprene underlay with 60 micron vapour barrier. Supplied in 20 m ² rolls, 1100 mm wide, with pre-applied adhesive tape and 8 cm vapour barrier overlap. Area mass: approx 0.36 kg/m ² .

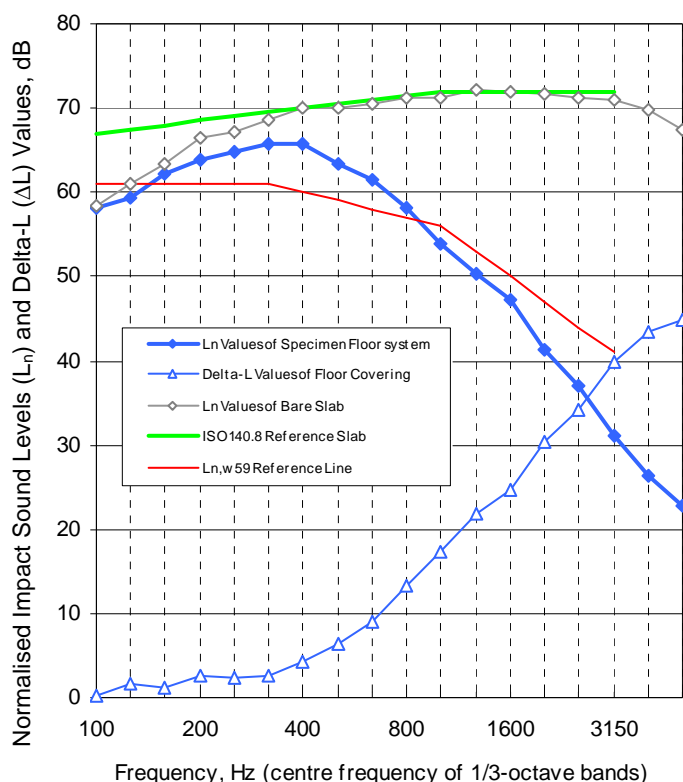
Impact Sound Data for the concrete test-slab with the Floor Covering described above.

Note: \geq and \leq indicate levels, if any, where measurability was limited by background level.

Freq (Hz)	Normalized Impact SPL (dB)		Improvement ΔL (dB)
	Bare Floor	With Floor Covering	
100	58.5	58.2	0.3
125	61.1	59.4	1.7
160	63.4	62.1	1.3
200	66.5	63.9	2.6
250	67.1	64.8	2.3
315	68.5	65.8	2.7
400	70.1	65.8	4.3
500	70.0	63.5	6.5
630	70.6	61.6	9.0
800	71.3	58.1	13.2
1000	71.3	53.9	17.4
1250	72.1	50.3	21.8
1600	71.9	47.2	24.7
2000	71.7	41.4	30.3
2500	71.3	37.1	34.2
3150	70.9	31.0	39.9
4000	69.7	26.3	43.4
5000	67.5	22.7	44.8
ΔL_w	-	-	17
ΔL_{in}	-	-	7
IIC	29	51	-
$L_{n,w}$	78	59	-
C_1	-12	-1	-
$L_{n,w} + C_1$	66	58	-

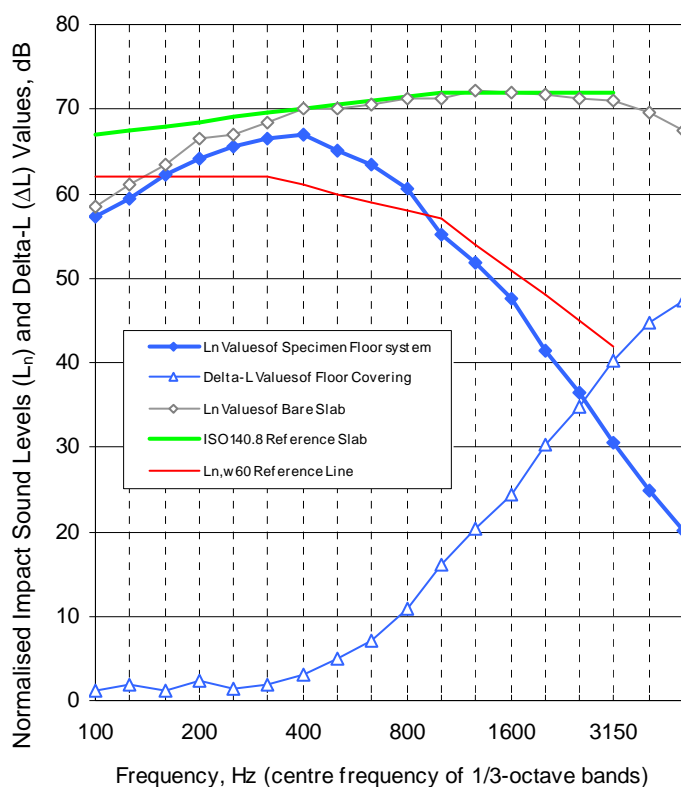
Impact Sound Data for the concrete test-slab with the Floor Covering described above.

Note: \geq and \leq indicate levels, if any, where measurability was limited by background level.

Freq (Hz)	Normalized Impact SPL (dB)		Improvement ΔL (dB)
	Bare Floor	With Floor Covering	
100	58.5	57.3	1.2
125	61.1	59.3	1.8
160	63.4	62.2	1.2
200	66.5	64.2	2.3
250	67.1	65.6	1.5
315	68.5	66.6	1.9
400	70.1	67.1	3.0
500	70.0	65.1	4.9
630	70.6	63.4	7.2
800	71.3	60.5	10.8
1000	71.3	55.1	16.2
1250	72.1	51.8	20.3
1600	71.9	47.5	24.4
2000	71.7	41.5	30.2
2500	71.3	36.4	34.9
3150	70.9	30.6	40.3
4000	69.7	24.9	44.8
5000	67.5	20.2	47.3
ΔL_w	-	-	16
ΔL_{in}	-	-	6
IIC	29	50	-
$L_{n,w}$	78	60	-
C_i	-12	-1	-
$L_{n,w} + C_i$	66	59	-
